**NUMBER:** 18-012-16

Flash: 3.0L Powertrain Diagnostic and System Improvements

2014 (WK) Jeep Grand Cherokee

**NOTE: This bulletin applies to vehicles equipped with a 3.0L diesel engine (Sales Code EXF) and 8 speed transmission (Sales Code DFD).**

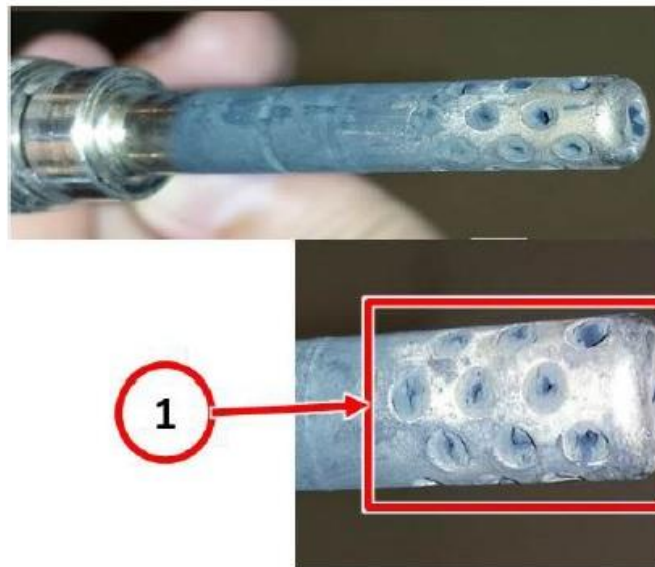
**Fig. 1 EGT Sensor Bank 1 Sensor 1**

10. Remove the EGT Sensor 1/2 located in the inlet of the Diesel Particulate Filter (DPF)/Diesel Oxidation Catalyst (DOC) assembly. Refer to detailed removal procedures available in DealerCONNECT> TechCONNECT> Service Info Section 11 - Exhaust System> Sensor, Exhaust Temperature> Removal> Exhaust Gas Temperature Sensor 1/2.
11. Remove the Catalyst Temperature Sensor located in the middle of the Diesel Particulate Filter (DPF)/Diesel Oxidation Catalyst (DOC) assembly. Refer to detailed removal procedures available in DealerCONNECT> TechCONNECT> Service Info Section 11 - Exhaust System> Sensor, Exhaust Temperature> Removal> Catalyst Exhaust Temperature Sensor.
12. Inspect the sensor body and probe for any signs of damage or excessive soot. See (Fig. 1).

1 - Excessive soot blocking sensor ports

- 
13. Was excessive soot found on the sensor?
    - a. Yes>>> Proceed to [Step #14](#).
    - b. No>>> Proceed to [Step #15](#).
  14. Using shop air set to a maximum of 80 psi, clean all excessive soot from the sensor probe.
  15. Using a suitable multi-meter with appropriate test probes, test the resistance between the sensor connector terminals 1 and 2. With the sensor at room temperature, 65-75 °F (18-25 °C), the resistance should measure between 200 and 240 ohms.
  16. Is the temperature sensor resistance within specifications?
    - a. Yes>>> Install the original EGT sensor 1/2 and/or Catalyst Temperature Sensor. Refer to detailed installation procedures available in DealerCONNECT> TechCONNECT> Service Info Section 11 - Exhaust System> Sensor, Exhaust Temperature> Installation> Exhaust Gas Temperature Sensor 1/2.
